# MUNICIPAL - THE PICOTE WAY

# POTABLE WATER INFRASTRUCTURE COATING

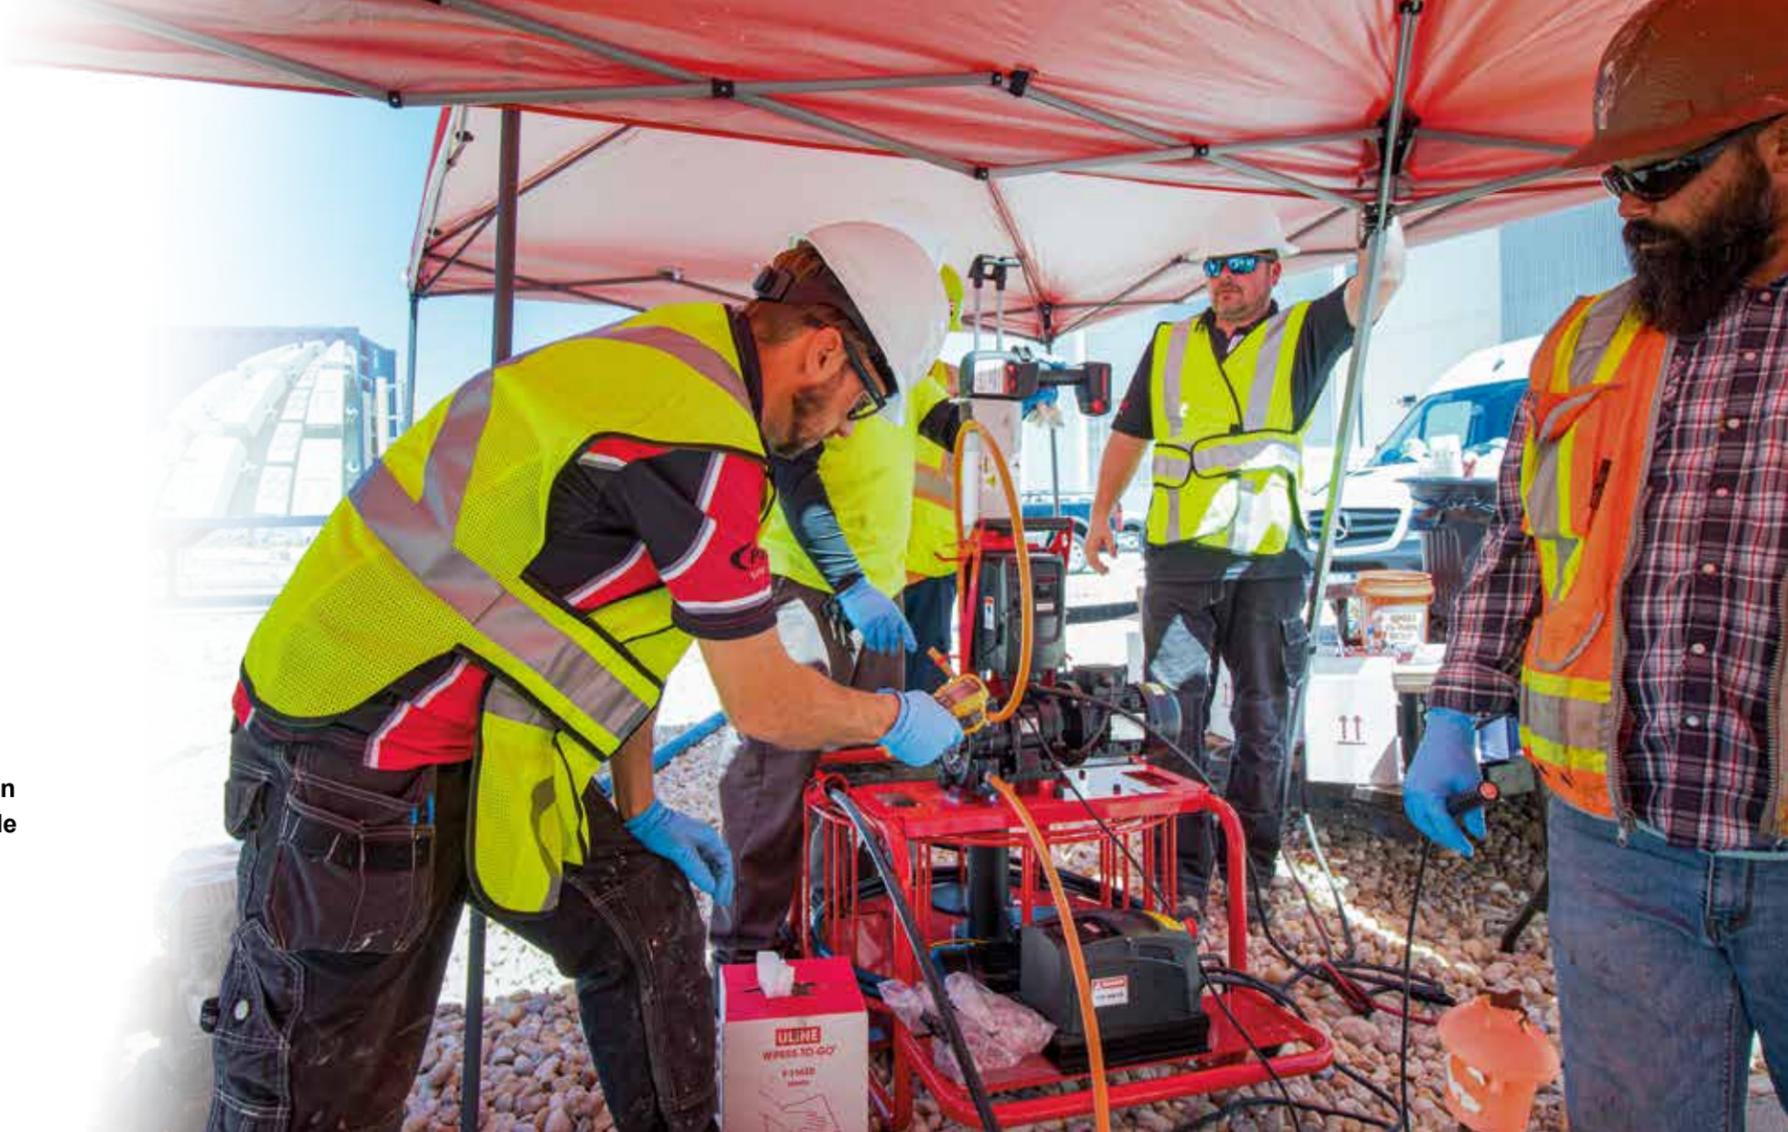
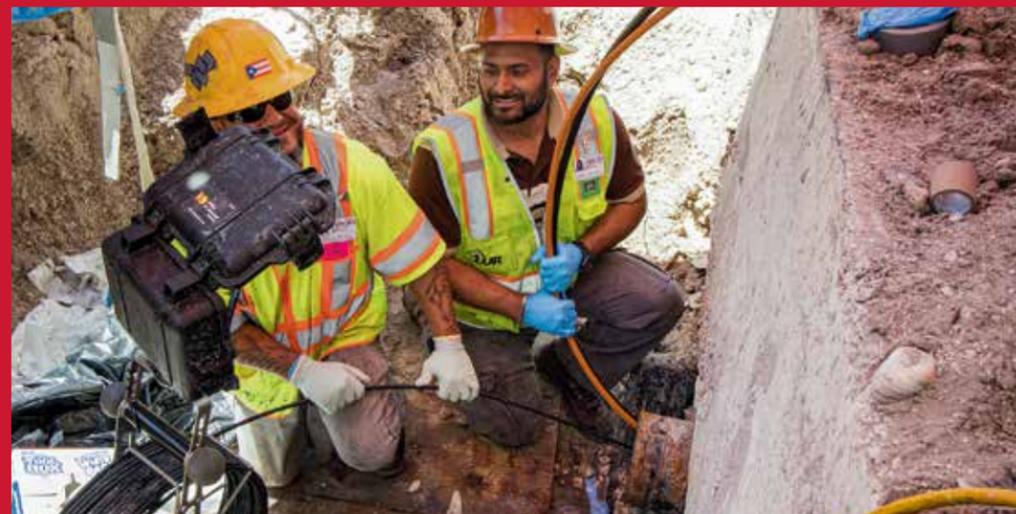
< Picote's Maxi Coating System is being used to rehabilitate a 50+ year old potable water main at NASA's Cape Canaveral site. This water main is 8" in diameter and serves a major part of the shuttle launch facility.

Installation of 5 coats of Picote's Dual Color 100% Solids Epoxy in an 8" potable water supply line that was installed in the 1960's. The Maxi Coating Pump was used.

Due to the location of the pipe, excavation would have been extremely costly and difficult. The Picote Brush Coating™ System provided a fast and easy renovation while the facility maintained access to the road above.

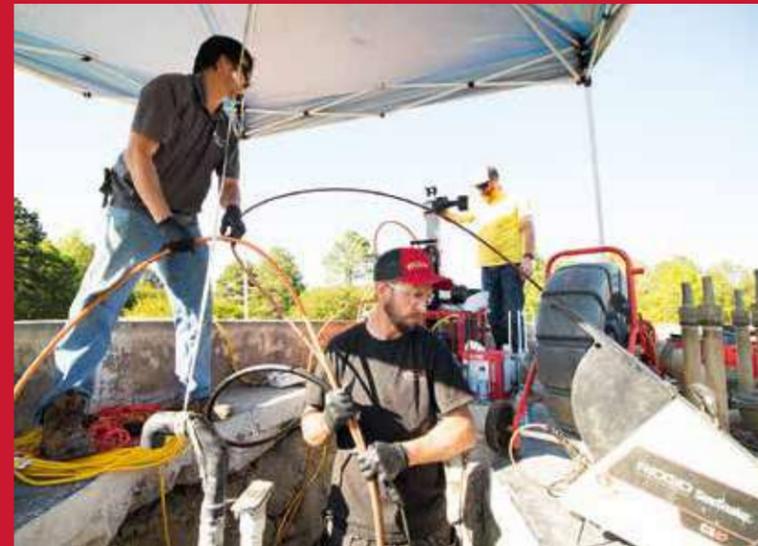
With the right number of coats added to a pipe, Picote's epoxy coating can withstand operating pressures upwards of 150psi. This capability makes our coating a great repair option for pressure pipes of all kinds, including: pools, fountains, force mains, fire suppression lines and more. Pipe condition, type and temperatures will all be a factor and should be considered before undertaking work.

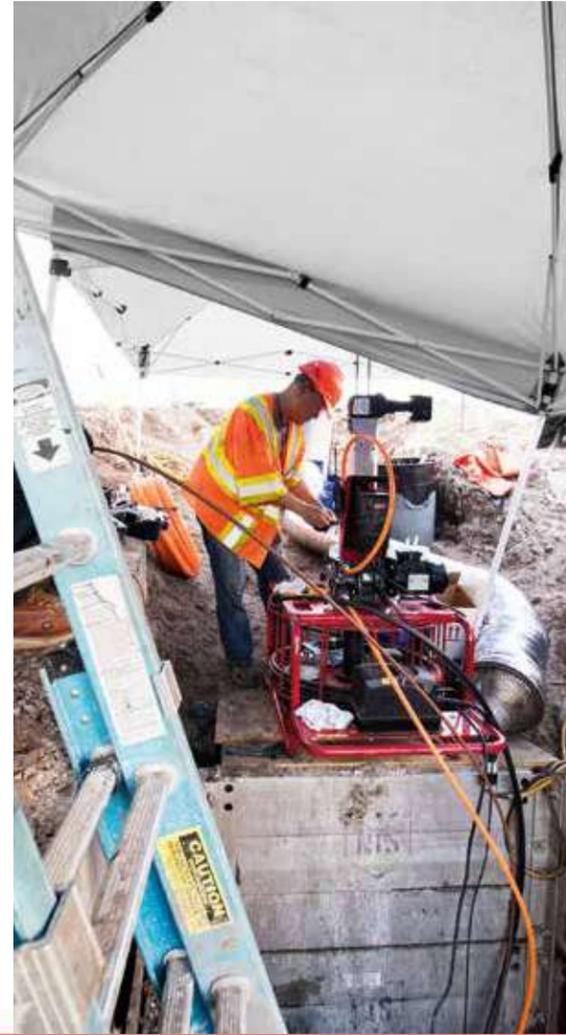
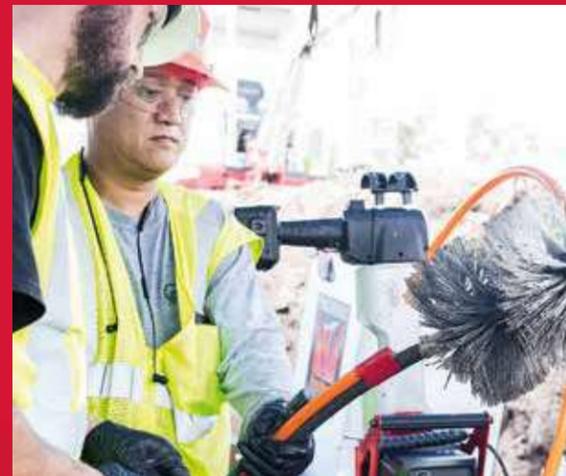
Picote's coating process has been used to renew wastewater clarifier drains where heavy use, caustic and corrosive environments are a constant.

Multiple rehabilitations of the drain lines can be accomplished in a day.

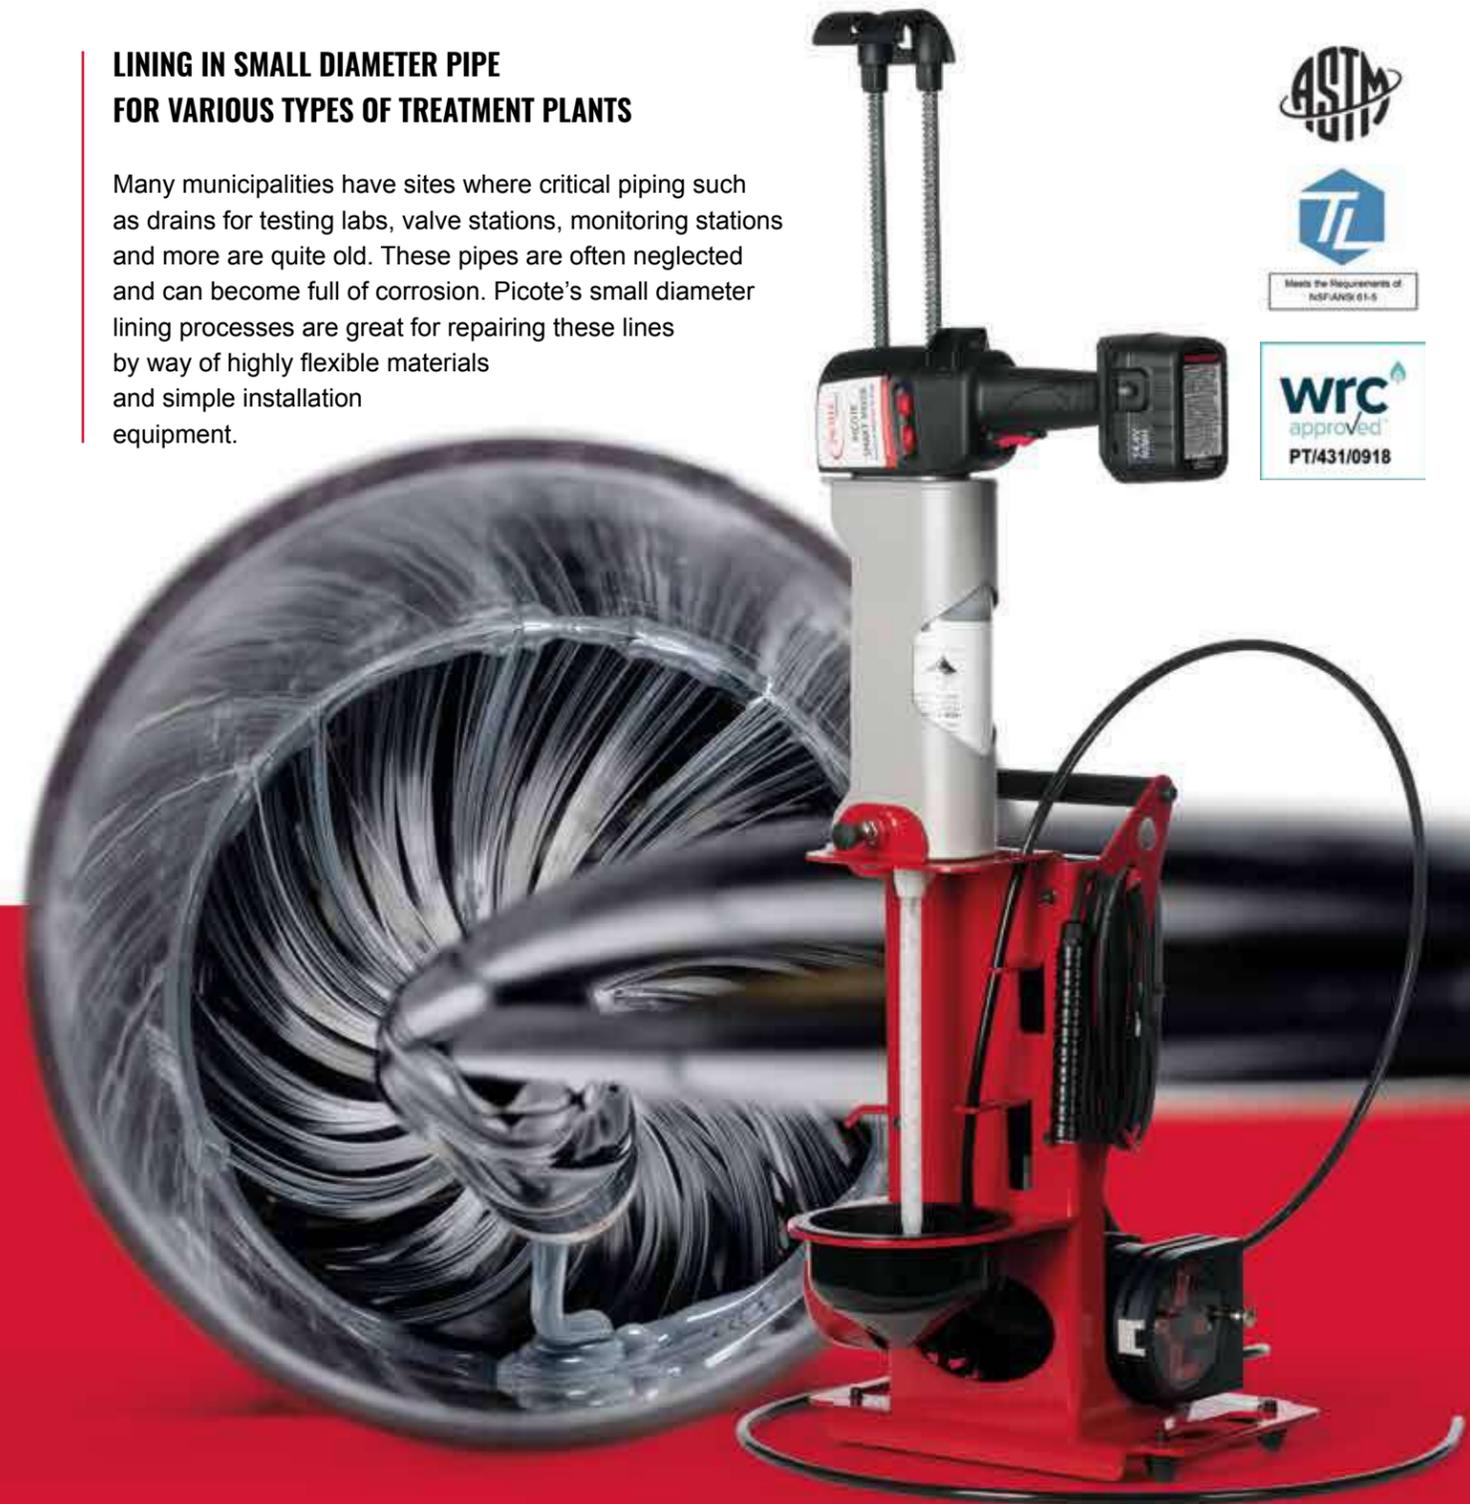
## LINING IN SMALL DIAMETER PIPE FOR VARIOUS TYPES OF TREATMENT PLANTS

Many municipalities have sites where critical piping such as drains for testing labs, valve stations, monitoring stations and more are quite old. These pipes are often neglected and can become full of corrosion. Picote's small diameter lining processes are great for repairing these lines by way of highly flexible materials and simple installation equipment.

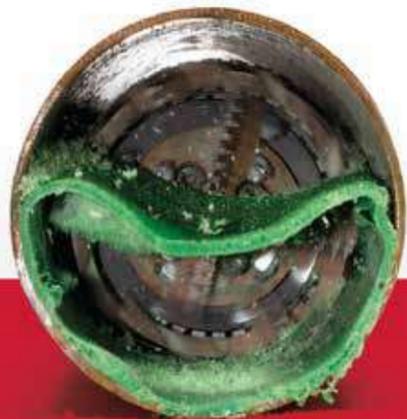
Sometimes a liner is installed and is acceptable aside from some minor imperfections like fins, wrinkles and slugs of resin. Picote's tools can remove these types of blemishes and can even polish the liner back to a visually appealing and functional state.

# REMOVAL OF FINNS, WRINKLES AND RESIN SLUGS

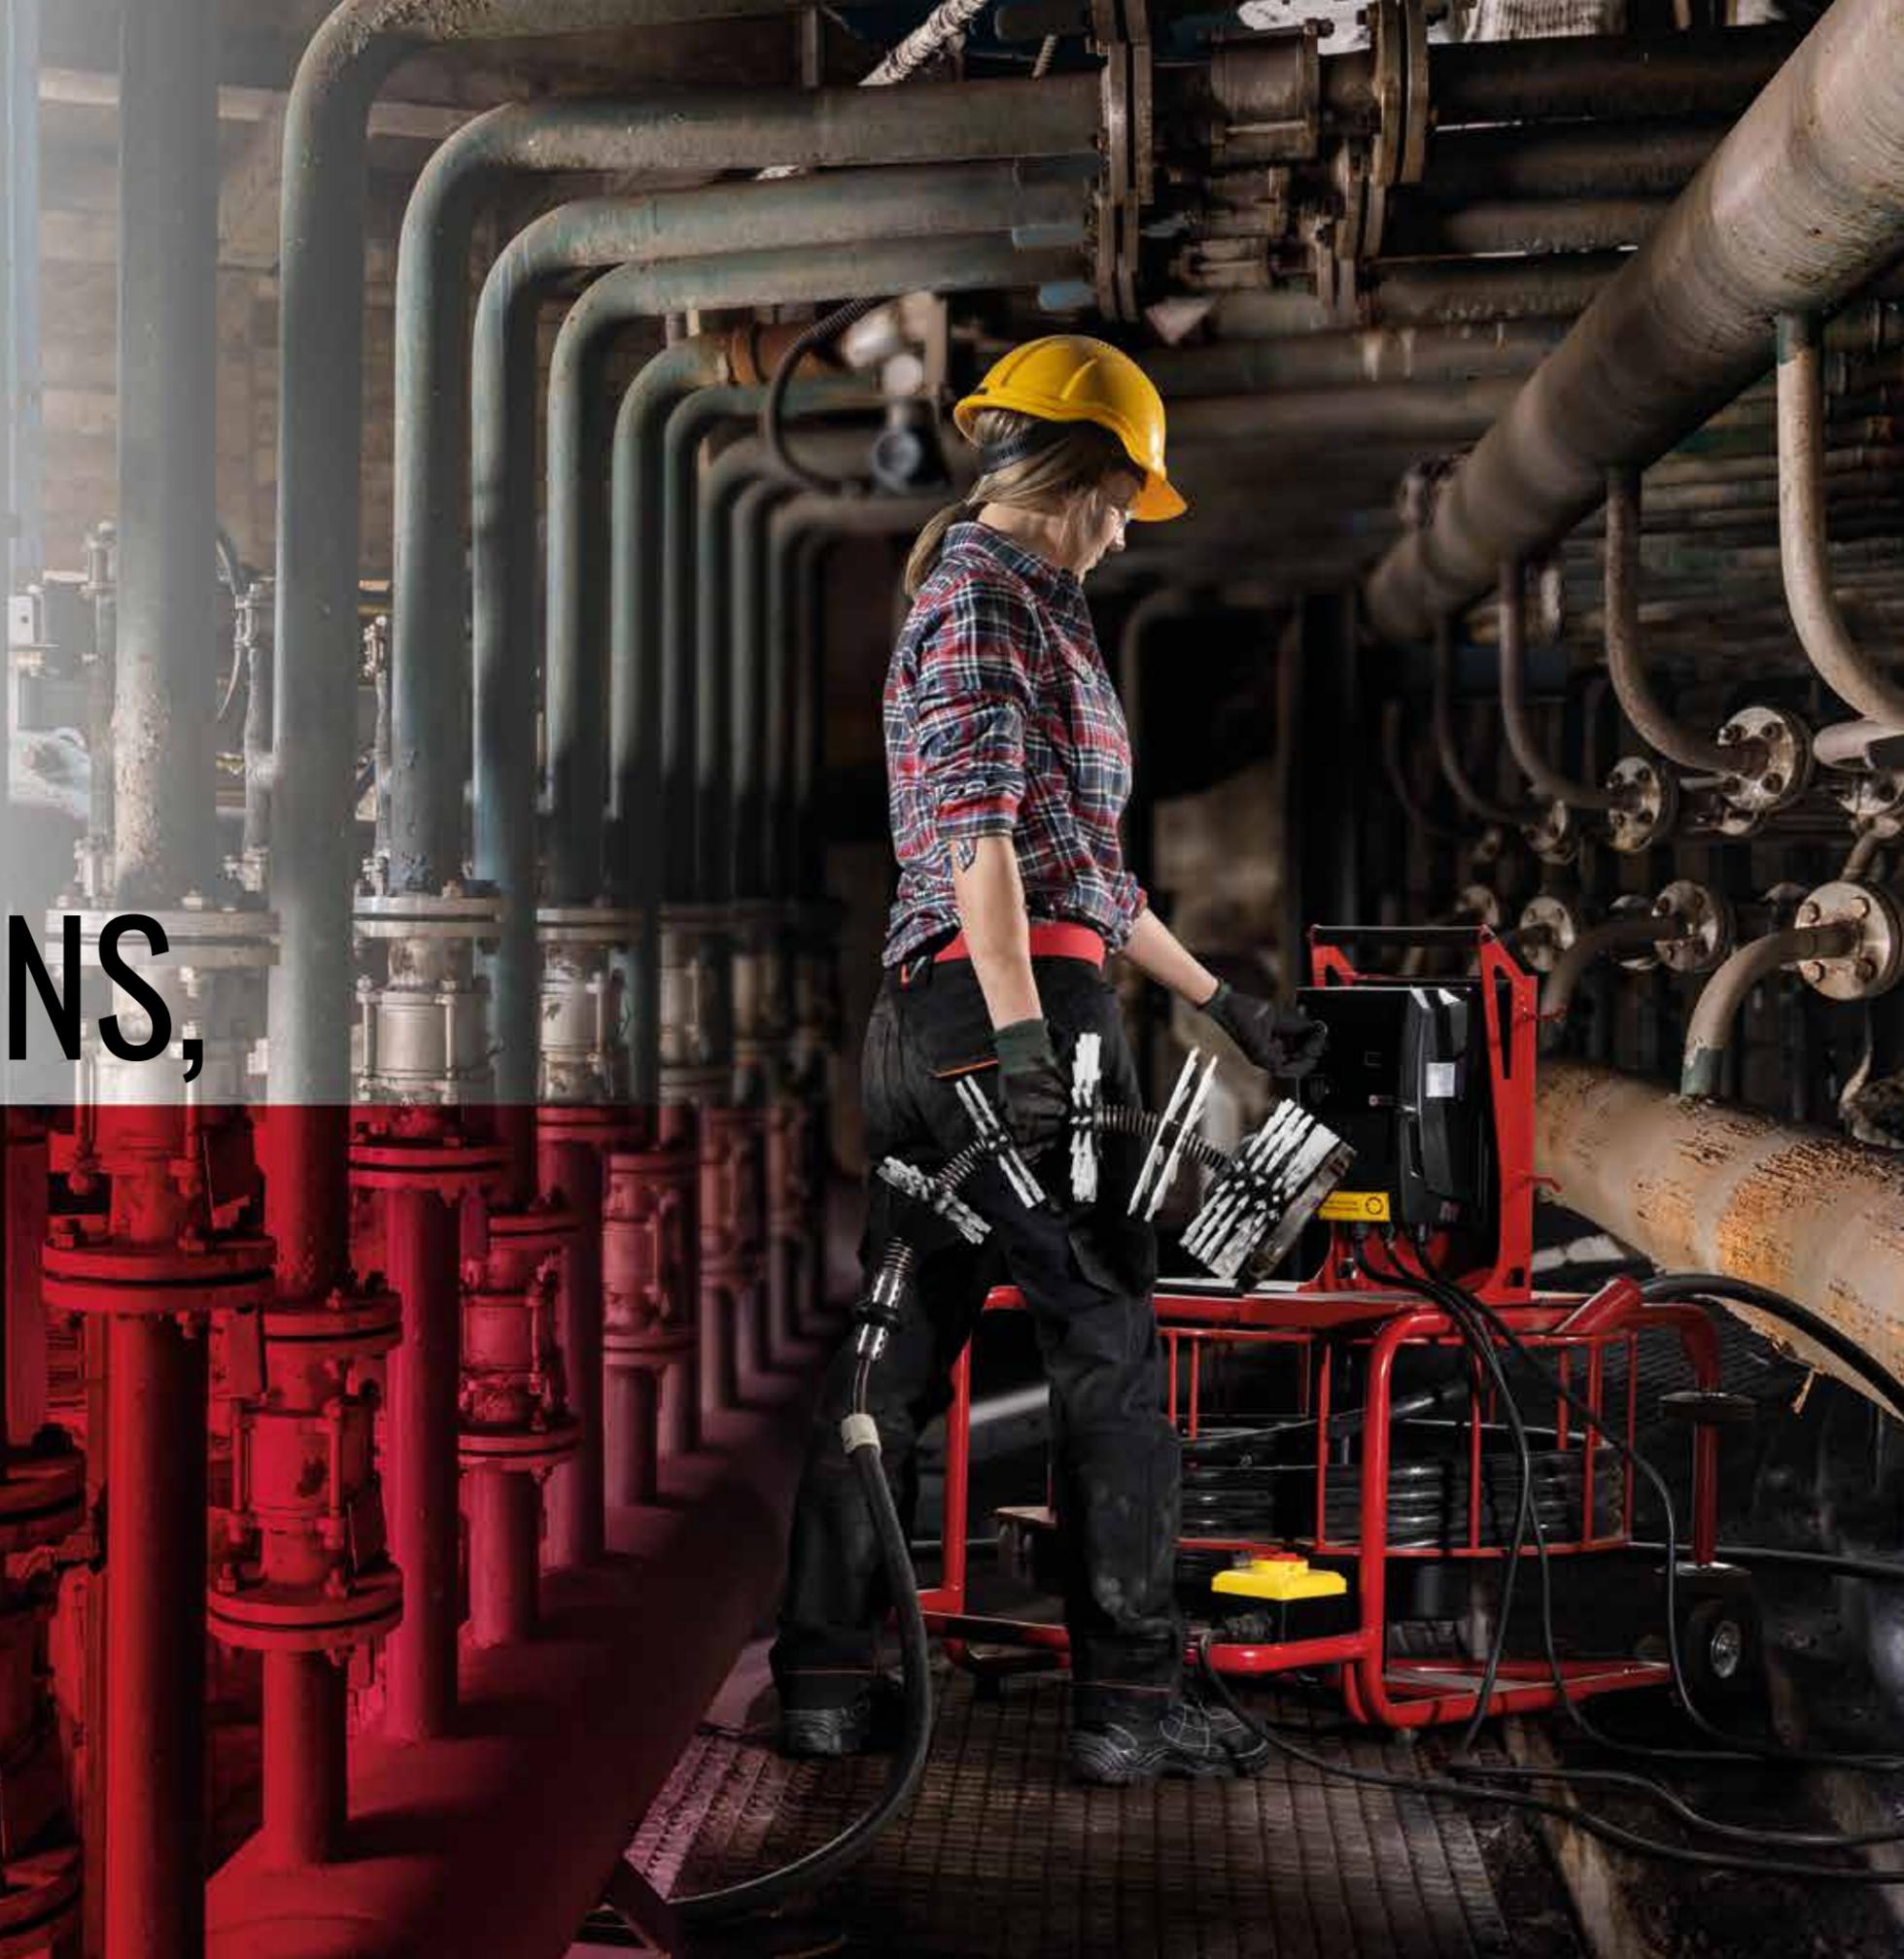
CIPP lining has been a standard practice now for many years. Many older installations are nearing their end of life, showing signs of failure, and will need to be removed. Sometimes the unexpected happens and an install just doesn't go well for a number of reasons and a lining may need to be removed immediately. Often these poor installations are found later when problems arise and will then need to be removed. No matter what the scenario, Picote has a solution for removing the problem.

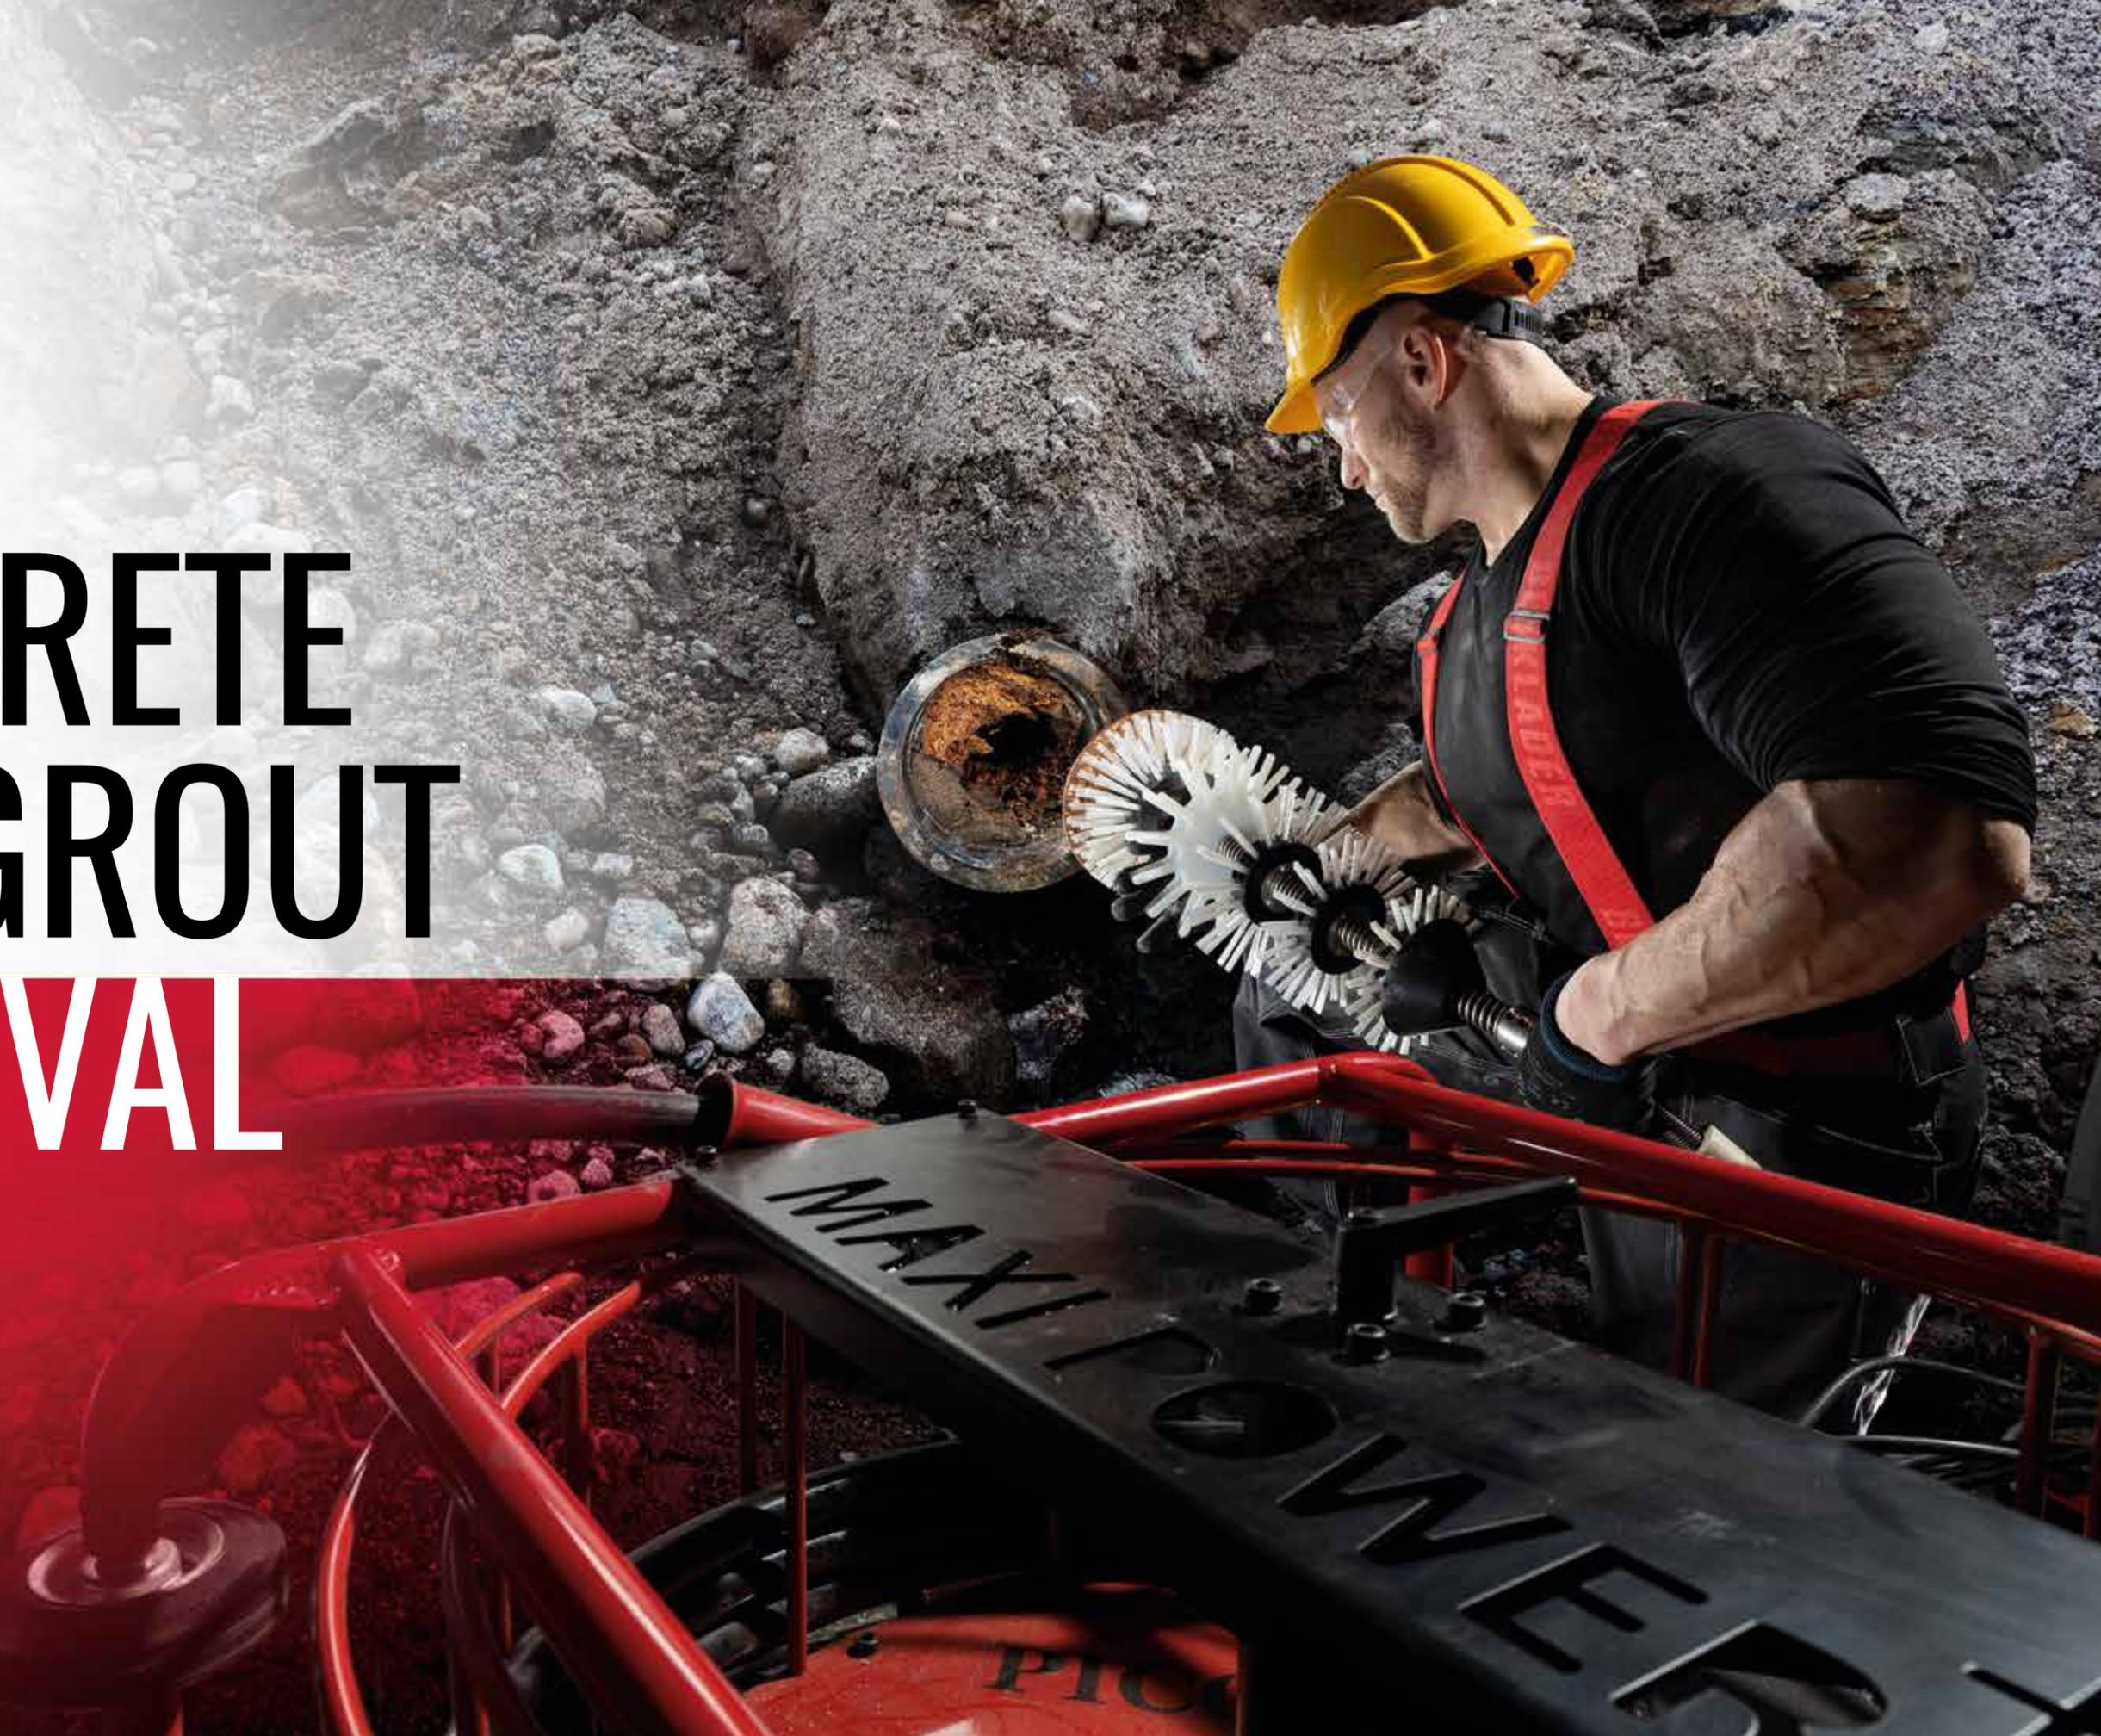
It is very common to find concrete and grout in pipes. These cases can cause major difficulty with flow or prevent the ability to navigate these lines. Picote's unique line of grinding tools is specifically designed to remove these types of blockages.

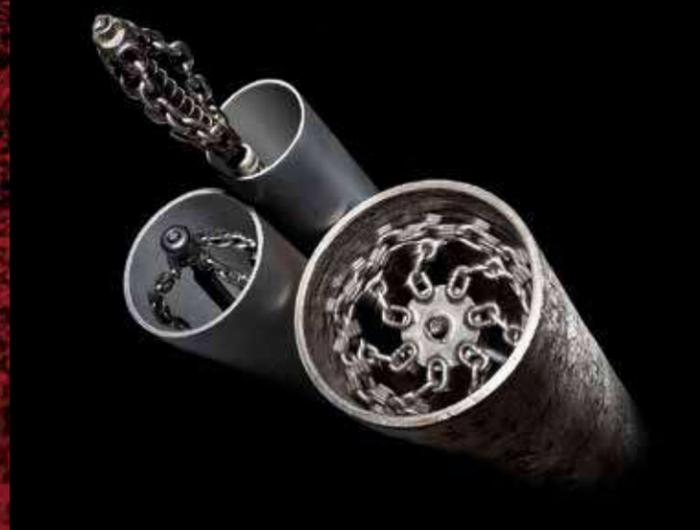
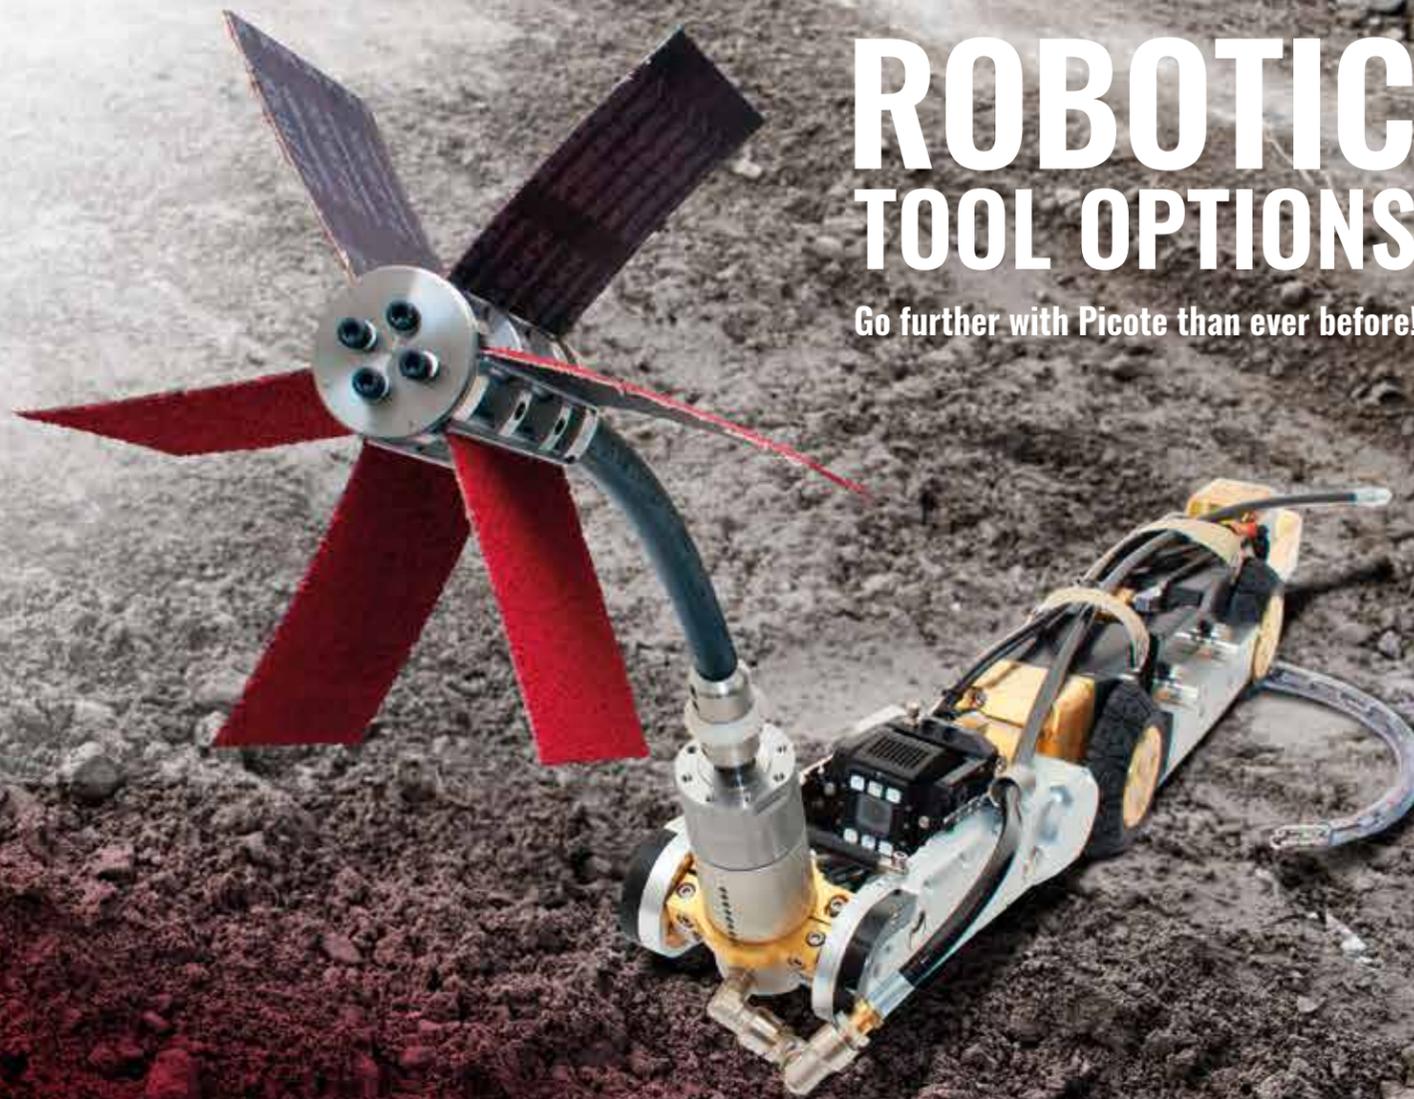
Larger pipes require bigger tools and a longer reach. When this is the case, Picote has a robotic tool range that is designed to be fitted to the world renowned Schwalm Robotic Talpa series cutter. Together with Schwalm's engineering team, Picote has created tools that can perform challenging tasks such as grinding, cutting and cleaning. It is also possible to grab lost items or remove obstructions with the Grabber pincher jaws mounted on board with a HD camera for precision work.

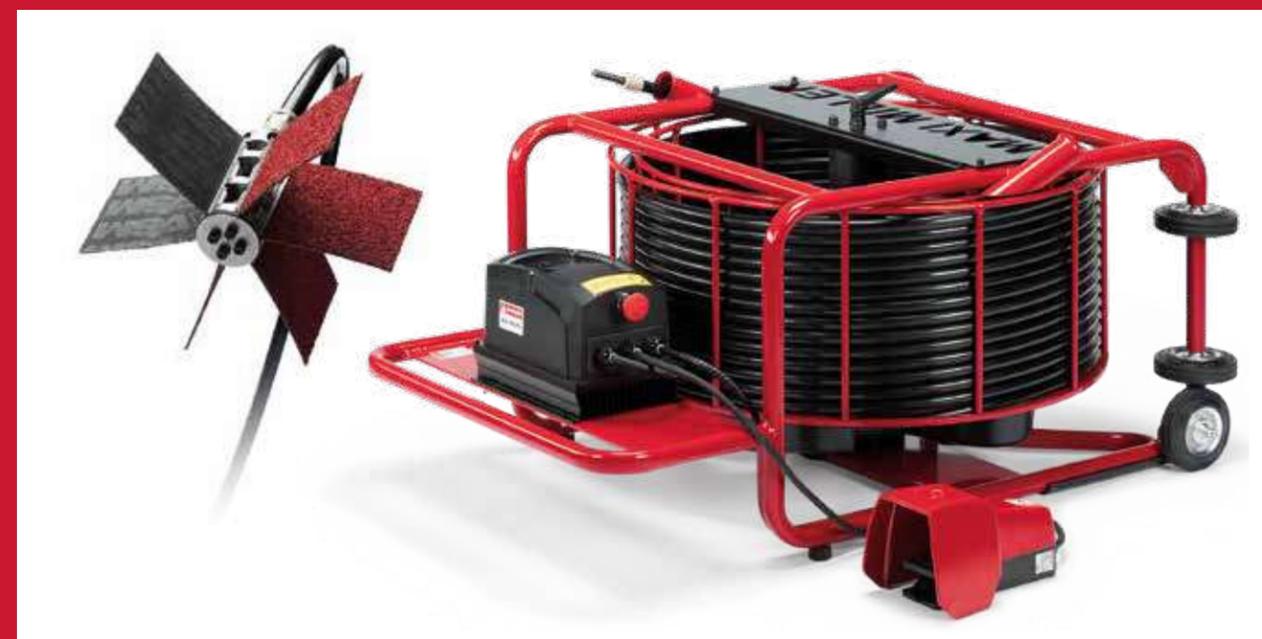
Large CIPP projects in mainlines can often times mean a fast paced installation process and a much faster process of returning lateral connections to service so as to avoid backups. In this fast paced process, connections are often left only 75 to 90 percent open, so there is potential for debris to catch on jagged edges left by the robotic reinstatement cutters. Picote's Smart Cutter™ coupled with one of our high speed milling machines can be a fast answer for municipalities to address these undercut connections and avoid responsibility for property damage caused by backups.

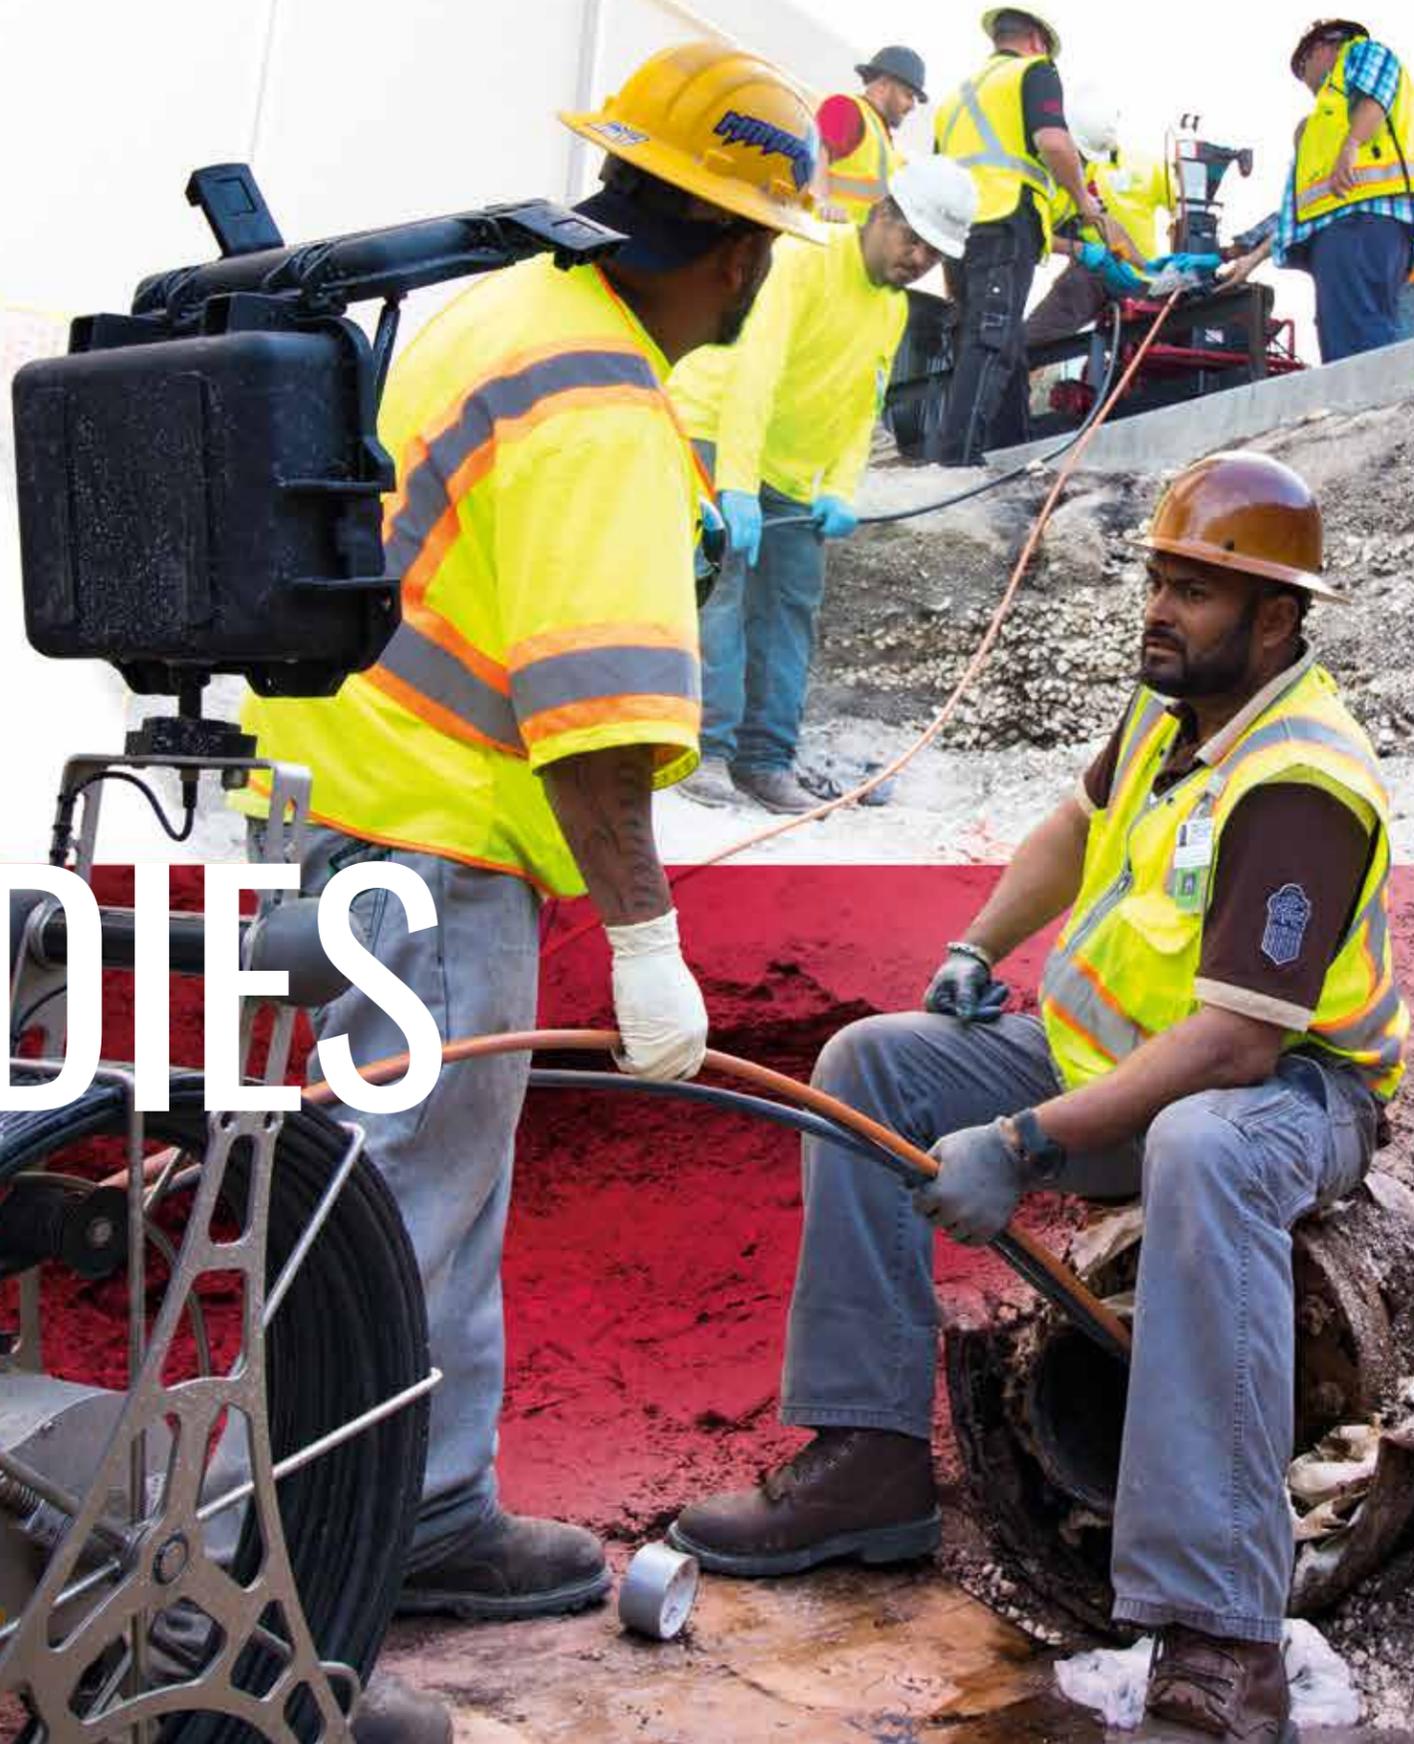
## **Nuclear Plant | Washington, USA (2017)**

Coated 140' of 4" cast iron waste line in a nuclear facility to seal waste piping to ensure no waste was leeching into the ground causing contamination of surrounding soil. Lead joints in the pipe had failed over time and were starting to leak and cause problems.

Sealed off exfiltration from the line and filled in failed joints.
